Pedestrian / Bicycle Safety Audit

US 41 from Commercial Drive to Guilford Road Airport Pulling Road from US 41 to Estey Avenue

Task Work Order No. 10
District-wide Safety Study and Minor Design
FPN No.: 430852-1-32-01
FDOT Contract No.: C-9945

June 2015

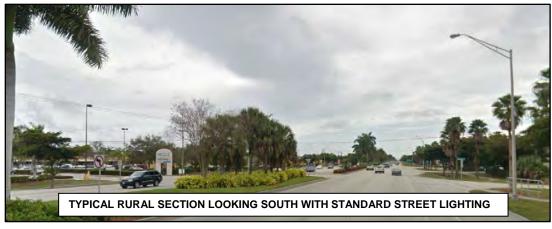
There are six signalized intersections within the study corridor and the following map shows the location of each:

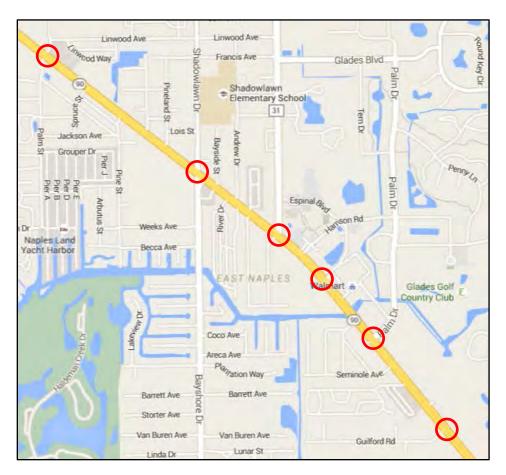
- 1. Commercial Drive / Palm Street
- 2. Shadowlawn Drive / Bayshore Road
- 3. Airport Pulling Road / Peters Avenue
- 4. Courthouse Shadows
- 5. Palm Drive
- 6. Guilford Road

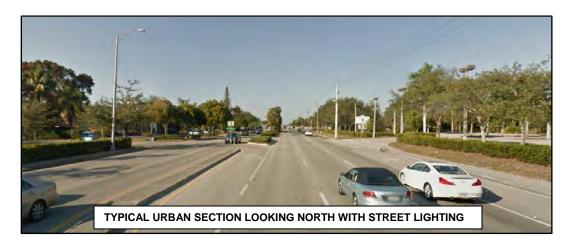
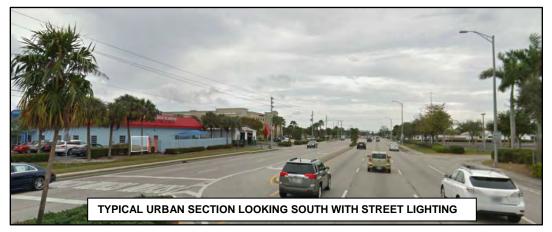
There are four signalized intersections within the Airport Pulling Road study corridor and the following map depicts each location:

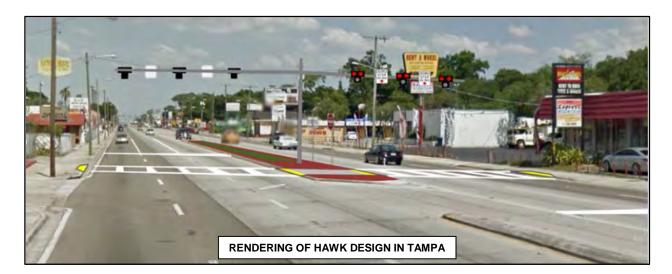
Consider installation of the Pedestrian Hybrid Beacon (PHB), commonly known as the HAWK (High Intensity Activated Crosswalk), to provide a controlled crossing for pedestrians and bicyclists that are crossing in-between signalized intersections. The photo below shows a rendering of a proposed mid-block crossing location in Tampa for a similar six-lane divided facility. The beacons are dark until activated and then the following sequence ensues:

- DRIVER flashing yellow PEDESTRIAN – DON'T WALK
- 2. DRIVER solid yellow PEDESTRIAN DON'T WALK
- 3. DRIVER solid red PEDESTRIAN WALK
- DRIVER flashing red PEDESTRIAN – flashing DON'T WALK
- DRIVER dark PEDESTRIAN – solid DON'T WALK

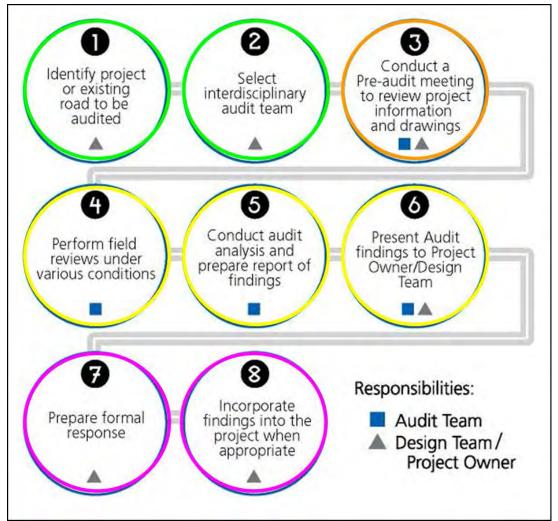
Steps in the RSA Process

- Conduct Pre-Audit Meeting (Now)
 - Site conditions
 - Traffic characteristics
 - Crash experience
- Perform Field Review (Mid-day)
- Conduct Audit Analysis (Late afternoon)

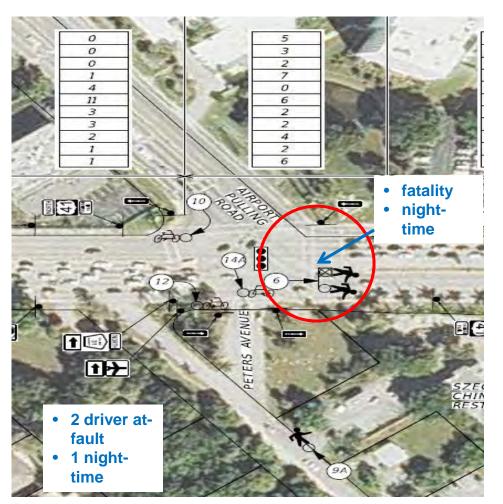
High Crash Location – US 41 @ Airport Pulling Rd

The one fatal pedestrian crash occurred on March 9, 2010 at 9:33 PM in the vicinity of the signalized intersection of US 41 and Airport Pulling Road. Two female pedestrians, aged 20 and 22, crossed from the north to south side of US 41 just east of the marked crosswalk located on the east leg. Both pedestrians were struck by an eastbound motorist, age 19, having the right-of-way and traveling with the green signal. The motorist fled the scene so we do not know if alcohol was involved. During the nighttime field review this intersection was observed to be poorly lit.

The westbound US 41 to northbound Airport Pulling Road right turn is a prominent movement at this intersection. The RSA Team observed the right turns moving at a high speed due to the large corner radius on the northeast corner thus creating concerns for pedestrians / bicyclists standing on the corner or trying to cross. The driver's view of the crosswalk and view of anyone waiting on the northeast corner is also obstructed by the mast arm pole. The eastbound to southbound right-turn movement has an unsignalized slip-lane that is easily missed by approaching motorists and creates an additional pedestrian crossing with a
